## HydraTite Seal

**Project:** 78" Expansion Joint

**Application:** Power Generation Pipeline

**Installation:** September 2008

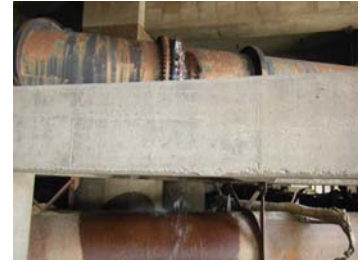
Leaking 78" Circulating water pump expansion joint. During a walk down inspection in August of 2008 by client's personnel, it was identified that the expansion joint in question was cracked externally.

Engineers had walked down the project, reviewed drawings and system operating parameters and provided an engineered solution. This solution utilized the HydraTite Seal consisting of three (3) two piece 304 stainless steel bands, a double wide EPDM seal and a 16 gauge stainless steel backing plate to provide an internal slip joint repair.
