HydraWrap (Fiber Reinforced Polymer)

Project: Circ Water

Engineer Solution: Repair of the 108" Pre stress Concrete Pipe (PCCP)
-Circulating water cooling Tower Basin.

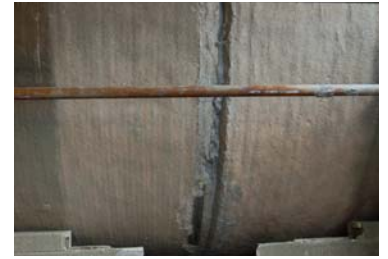
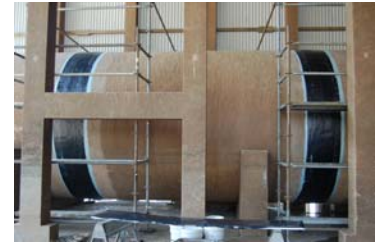
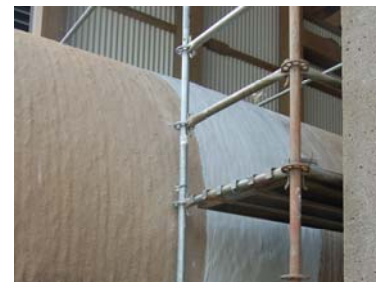
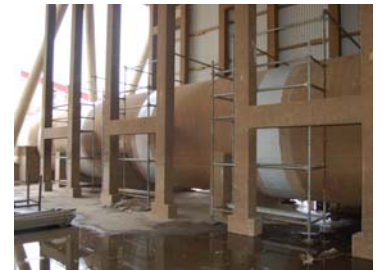
Substrate / Area: Exterior of 108" ID PCCP has deteriorated to expose tension wires.

Engineers walked down the project, reviewed drawings and system operating parameters and provided an engineered solution. This solution utilized the HydraWrap, a system of Carbon Fiber reinforce polymer that was to be applied over the broken pre stressed wires and encase the subject area.

The exterior of the piping was prepared by removing all loose materials, and grit blasting the surface to remove any dirt and loose debris. Once this process was completed a cement grout was used to fill in all voids to bring the pipe back to original shape. Once this process was completed the HydraWrap System was applied to not only encapsulate concrete pipe and repairs, but to provide assurance that the systems is able to maintain design pressures.
