PolySpray

A large coal fired power plant in north central Pennsylvania required repair to a steel bypass piping that redirected cooling water from the cooling cells directly to the basin. This line consisted of 42 feet of 42" diameter carbon steel pipe that had severe erosion and corrosion. Of particular concern to client were two 90 degree elbows situated within the pipe that had severe wall loss and required immediate attention. The project to rehabilitate the piping was urgent and only a 5 day work window for the rehabilitation could be accommodated within the start up schedule.

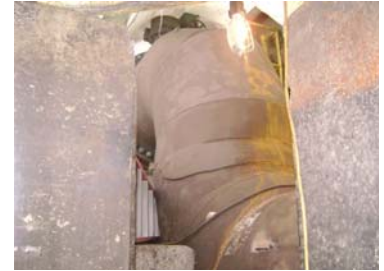
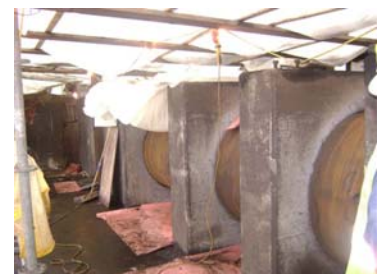
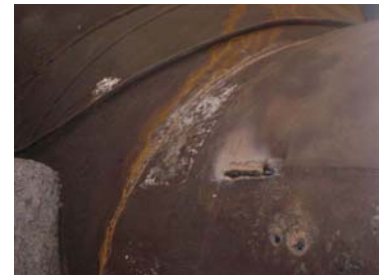
A HydraTech manufactured Epoxy filler (HydraLine) was used to address severe pitting on the internal radius of the lower 90 degree bend of the pipe fitting. The butterfly valve was masked off to prevent overspray and debris from accumulating on the valve disk and seat. Once the pipe was clean of all debris and personal were clear of the piping the piping was lined. The process took less than a day to complete. Some touch up work was performed the following day and the piping went back in service without any leaks and its operational life was extended.

The client chose the third option of PolySpray SS100. Once agreed project required working window of only 5 days. This included the manufacturing of material, mobilization and installation. To reduce installation time the pipe was grit blasted to SSPC 6/NACE 3 commercial blast parameters, surface profile to 3-4 mils. To maintain the 75 psig rating of the system, engineering calculations specified a thickness of greater than 3 mm to line and prevent leakage within the system. Any through wall holes greater than .25 inches per weld, were welded.
