HydraTite Seal

Project: Nuclear Station 96" Circ Water

Application: Power Generation Pipeline

Product: HydraTite Seal

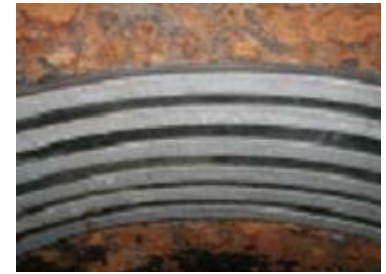
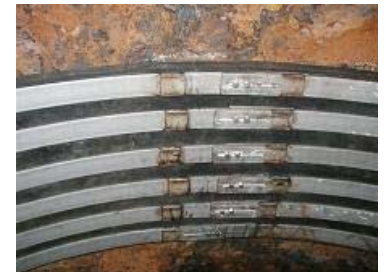
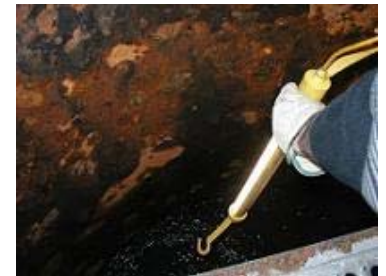
The circulating water box system requires a vacuum on the system to allow proper circulating water level in the water box to provide cooling through all tubes. This operating performance was degraded due to through wall leaks in the discharge piping that allowed atmospheric pressure to reduce vacuum levels and thus reduce cooling capacity of the condenser and overall electrical generation.

Engineers had walked down the project, reviewed drawings, system operating parameters and provided an engineered solution. This solution utilized the HydraTite Seal with six – three piece stainless steel 316 steel bands, a Double Wide HydraTite seal and a 16 gauge stainless steel backing plate that covered the degraded areas and eliminate air in leakage.

The crew and all materials entered through an existing manhole and were able to complete the system installation within the work window provided by the station. At the completion of the project the system performance was brought back to as built specifications with the nuclear plant able to operate at better efficiency and thus increase electric generating output.
