HydraWrap (Fiber Reinforced Polymer)

Project: Low Head Piping Rehabilitation

Application: Power Generation Pipeline

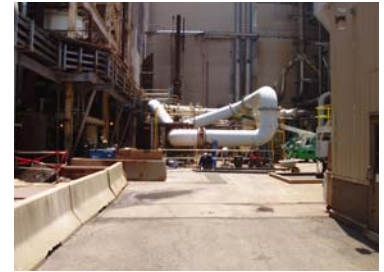
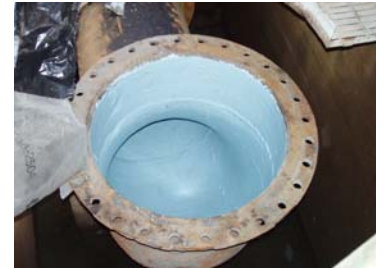
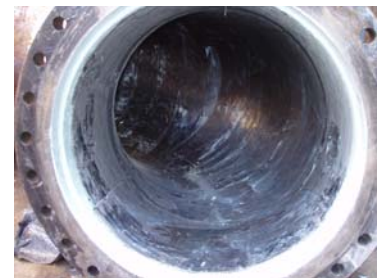
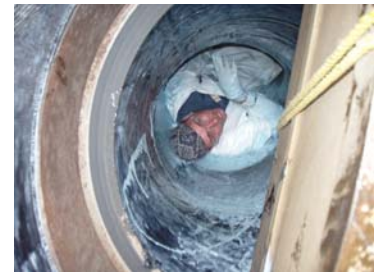
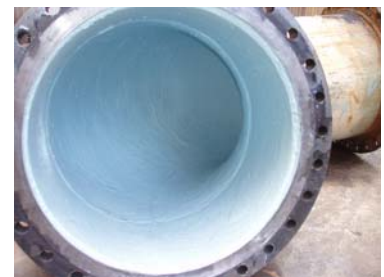
The Client selected the HydraWrap carbon fiber and epoxy repair system for its structural capacity, coupled with economic pricing and favorable schedule. The project commenced on May 2, 2007 and required the removal of the sometimes tenacious existing coatings. Selected pipe spools were removed and other openings were provided to allow access into the piping. The substrate was prepared by grit blasting. The entire piping system was repaired by applying an epoxy primer, a layer of carbon fiber and a top coat. The system was returned to service on May 24, 2007.
