Marine HydraWrap (Carbon Fiber Reinforced Polymer)

Helix Energy Solutions Group
Mobile Offshore Drilling Unit (MODU) Quantum 4000
No 5 Main Generator Cooling Water Pipe Repair

Marine HydraWrap - (1) 4" Elbow Kit

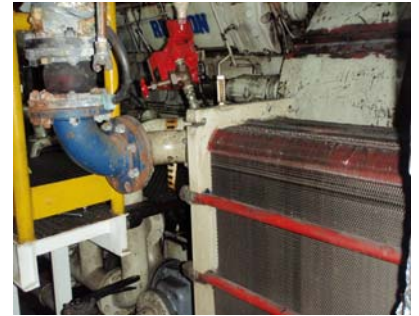
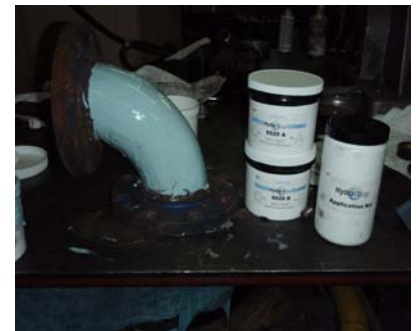
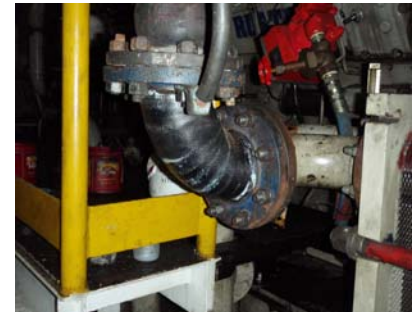
A pipe failure onboard the MODU Quantum 4000 occurred on the No. 5 main generator cooling water system. The leak caused by corrosion occurred on a carbon steel 4" SCH 80 short radius flanged elbow which is part of the salt water discharge from a titanium plate heat exchanger. The system pressure is 40PSIG (2.75 bar) and temperature is 105°F (40°C).

The Chief Engineer was made aware of Marine HydraWrap, which is Design Approved by the American Bureau of Shipping for shipboard piping repairs. A 4" Marine HydraWrap elbow kit was ordered, the surface prepared and the product was applied according to directions.

The crew was pleased with how well the product was packaged and how easy the directions were to follow for application. The repaired piping has been in operation and leak free for over a month and was critical in preventing downtime.
