HydraTite Seal

Project: DOT Joint Repair

Application: Storm Culvert

Product Used: HydraTite Seal

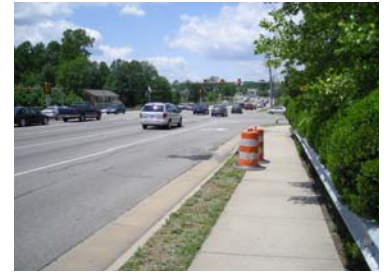
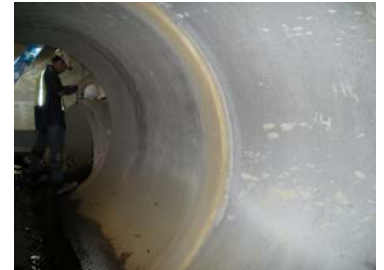
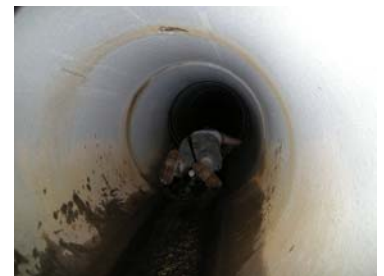
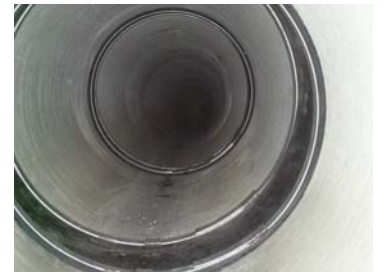
Inspection by Engineers revealed that the joints had opened up. In certain areas the joints had failed and storm water had eroded the surrounding soil producing sizable sink holes in the highway and surrounding areas.

To determine the most appropriate product an engineer inspected the lines. After approval of the repair by client, the HydraTite seals were manufactured and then installed in one day using trained personnel. The inspection, manufacture and installation were completed within 2 weeks of client authorizing the job to be started.

The crew and all materials entered through existing manholes and there was no above ground disruption to the traffic as the seals were installed.
