HydraTite Seal

Project: 77.5" Expansion Joints

Application: Power Generation Pipeline

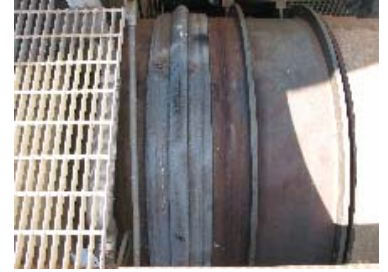
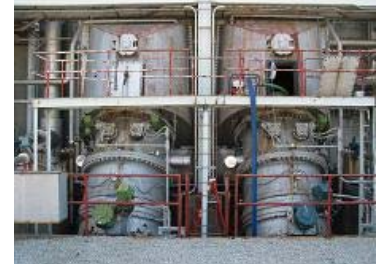
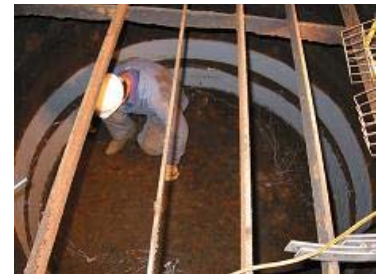
The repair of four 77.5" circulating water box expansion joints and two circulating water pump expansion joints.

Engineers walked down the project, reviewed drawings and system operating parameters and provided an engineered solution. This solution utilized the HydraTite Seal with three – two piece 316 stainless steel bands, an Extra Wide HydraTite seal and a 16 gauge stainless steel backing plate to provide an internal slip joint repair.

The crew and all materials entered through an existing manhole and were able to complete the system installation within the work window providing significant savings over traditional replacement of the expansion joints.
