## **Marine HydraWrap (Fiber Reinforced Polymer)**

Matson Navigation Company, Repair Fuel Oil Leak on MV Mahimahi

Marine HydraWrap - (1) 12" Weld Kit

Carbon Steel Fuel Transfer Piping

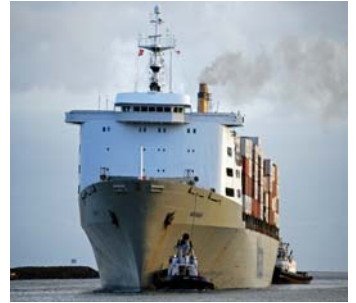
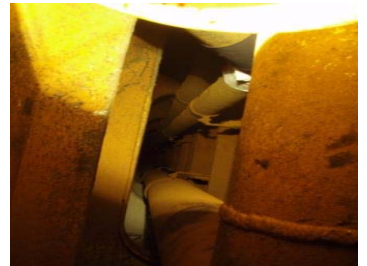
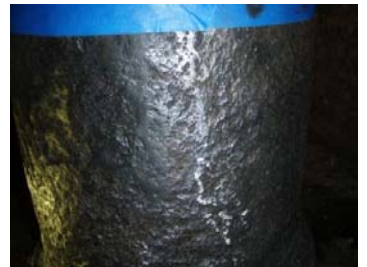
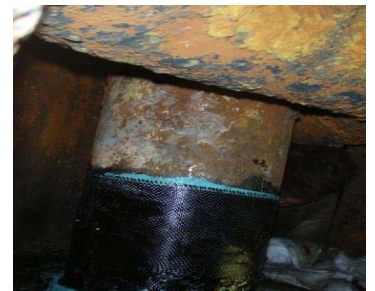
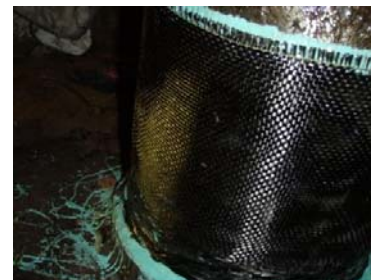
To repair a leak in the Heavy Fuel Oil (HFO) lines onboard the MV Mahimahi. The Leak was in a very confined area where time constraints in port were critical to meet schedule.

The Port Engineer contacted HydraTech Engineered Products and requested the Marine HydraWrap. The Marine HydraWrap is Design Approved by the American Bureau of Shipping for shipboard piping repairs. The Marine Acid repair kit was selected as it has superior resistance to fuel oil and was immediately shipped to the installer.

During routine cargo operations, the surface was prepared and Marine HydraWrap was applied according to the directions. The repair took an hour to perform and was successful in eliminating leakage during fueling operations.
