HydraWrap (Fiber Reinforced Polymer)

Ocean Shipholdings, Inc – Red Cloud RoRo Vessel

- (1) 18" X 24" Cooling (sea) water supply tee
- (1) 18" Cooling (sea) water supply elbow

HydraWrap, Carbon Fiber Structural Repair.

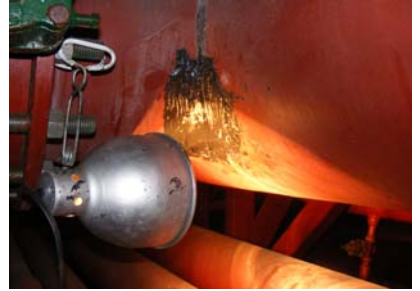
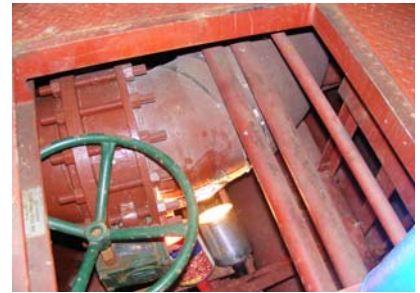
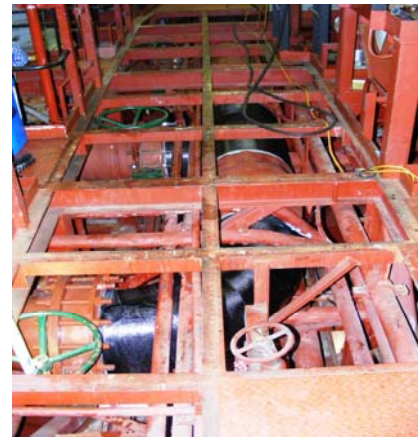
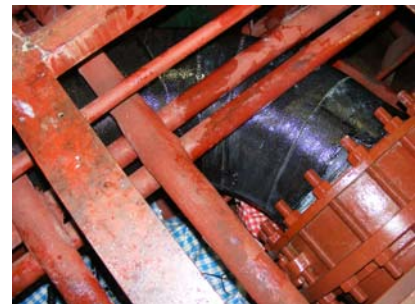
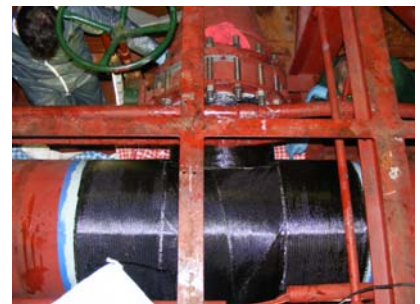
The cooling water system on the Red Cloud vessel experienced leaks and deterioration of the pipe wall. These leaks and deterioration were noticed primarily in the pipe fittings located immediately downstream of the supply pumps. Temporary patches and repair bands were implemented in the past to reduce the leaking. Still searching for a better repair, Ocean Shipholdings Inc, was introduced to HydraTech's ABS Design Approved Marine HydraWrap and requested repairs be made to several areas of the system where leaks had developed. The areas of the CuNiFe piping to be repaired were prepared and cleaned using hand tools and power tools to provide a clean surface and remove any foreign material.

HydraTech Engineered Products, LLC provided supervision and training services and Red Cloud vessel personnel completed the repairs on one 18" x 24" tee and one 18" elbow in one working day.
